UNIQUE DESIGN SOLUTIONS ACOUSTICAL PERFORMANCE TEST REPORT

ASTM E90 SOUND TRANSMISSION LOSS TESTING ON
VERTICAL ILLUSION, 3D WALL TILE ON A WALL SYSTEM

P0781.01-113-11-R0

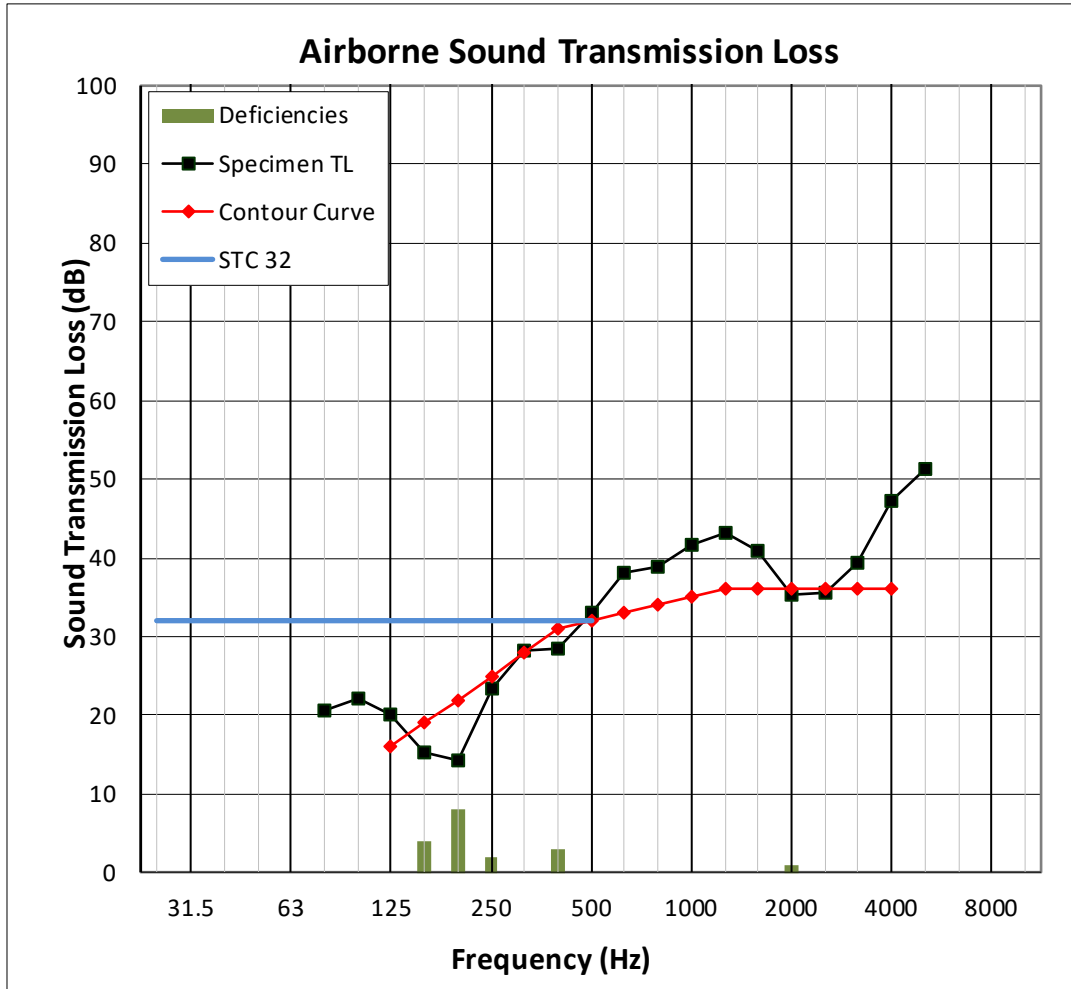
P0781.01A GRAPH (Base Wall Assembly)

P0781.01A DATA (Base Wall Assembly)

FREQ (Hz)	BACKGROUND SPL (dB)	ABSORPTION (m ²)	SOURCE SPL (dB)	RECEIVE SPL (dB)	SPECIMEN TL (dB)	95% SAMPLING LIMIT	NUMBER OF DEFICIENCIES
80	41.8	5.7	105	85	21	2.26	-
100	32.5	6.4	106	84	22	1.47	-
125	36.0	5.5	107	87	20	1.04	0
160	40.7	5.6	107	92	15	1.06	4
200	38.4	6.0	108	93	14	1.14	8
250	30.4	5.6	104	81	23	1.03	2
315	25.1	5.8	104	76	28	0.36	0
400	22.2	6.0	103	75	28	0.30	3
500	18.4	6.1	104	71	33	0.51	0
630	19.2	5.9	103	65	38	0.40	0
800	15.3	6.4	102	63	39	0.52	0
1000	11.1	6.5	103	61	42	0.32	0
1250	8.7	6.9	101	58	43	0.33	0
1600	6.8	7.4	99	57	41	0.15	0
2000	6.4	7.8	101	65	35	0.27	1
2500	6.4	8.9	102	65	36	0.23	0
3150	6.9	10.5	101	59	39	0.21	0
4000	7.6	13.1	99	48	47	0.31	0
5000	8.5	16.2	99	44	51	0.36	-
STC RATING	32 (Sound Transmission Class)						
DEFICIENCIES	18 (Sum of Deficiencies)						
OITC RATING	25 (Outdoor-Indoor Transmission Class)

DESCRIPTION	Base Wall Assembly
DATA FILE NO.	P0781.01A
STC	32
OITC	25

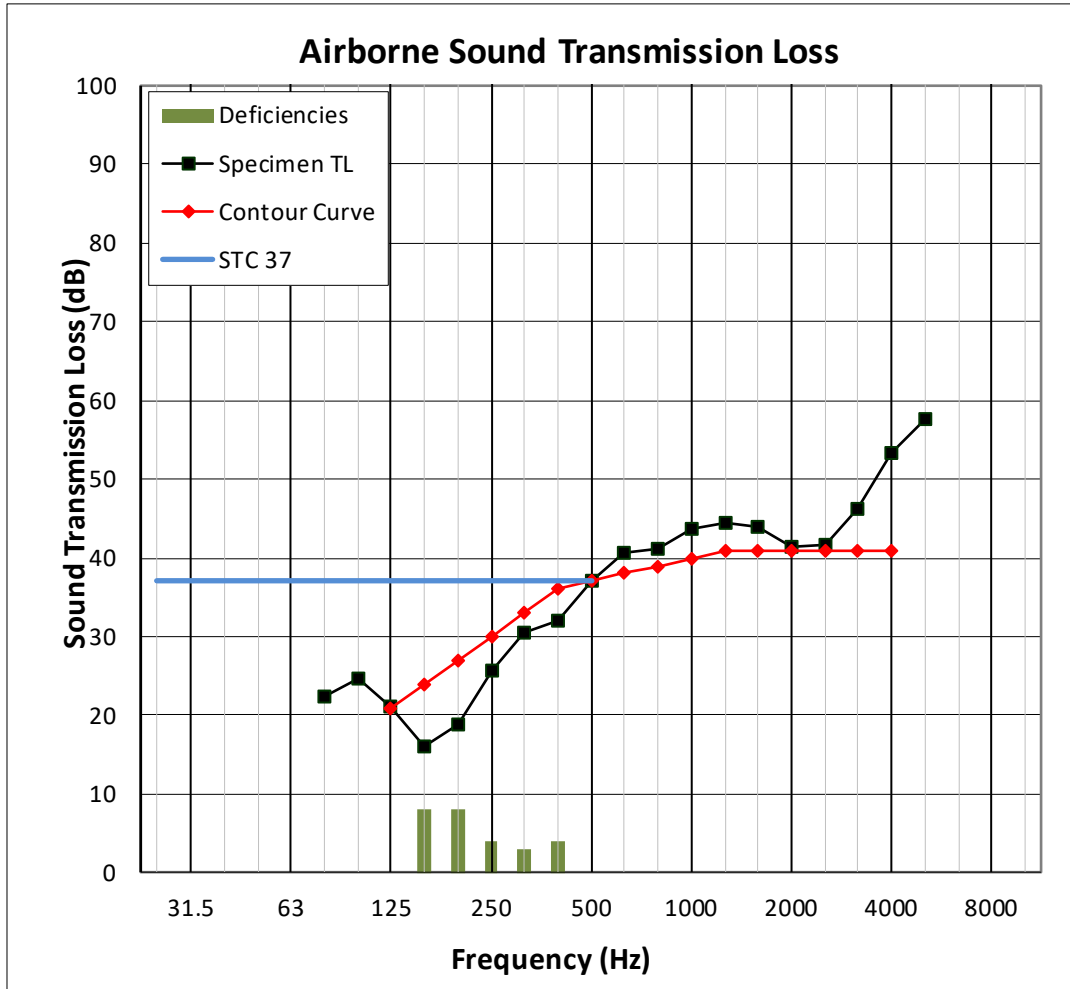
P0781.01B GRAPH (Base Wall Assembly with Vertical Illusion 3D Wall Tile)

P0781.01B DATA (Base Wall Assembly with Vertical Illusion 3D Wall Tile)

FREQ (Hz)	BACKGROUND SPL (dB)	ABSORPTION (m ²)	SOURCE SPL (dB)	RECEIVE SPL (dB)	SPECIMEN TL (dB)	95% SAMPLING LIMIT	NUMBER OF DEFICIENCIES
80	50.1	5.2	105	84	22	2.25	-
100	35.8	6.3	106	81	25	1.50	-
125	37.1	6.0	107	86	21	1.25	0
160	40.8	5.6	107	91	16	1.14	8
200	39.8	5.6	107	89	19	1.10	8
250	33.2	5.6	104	79	26	0.98	4
315	27.9	5.9	104	74	30	0.46	3
400	23.4	6.0	103	71	32	0.31	4
500	19.2	6.1	104	66	37	0.44	0
630	19.9	6.0	104	63	41	0.42	0
800	16.2	6.5	102	60	41	0.49	0
1000	11.7	6.5	103	59	44	0.33	0
1250	9.7	7.0	102	56	44	0.42	0
1600	7.6	7.5	99	54	44	0.15	0
2000	7.0	8.0	101	59	41	0.15	0
2500	7.6	9.1	102	58	42	0.19	0
3150	10.0	10.8	101	52	46	0.14	0
4000	9.5	13.5	99	42	53	0.29	0
5000	12.5	16.8	99	37	58	0.40	-
STC RATING	37 (Sound Transmission Class)						
DEFICIENCIES	27 (Sum of Deficiencies)						
OITC RATING	27 (Outdoor-Indoor Transmission Class)

DESCRIPTION	Base Wall Assembly with Vertical Illusion, 3D Wall Tile
DATA FILE NO.	P0781.01B
STC	37
OITC	27

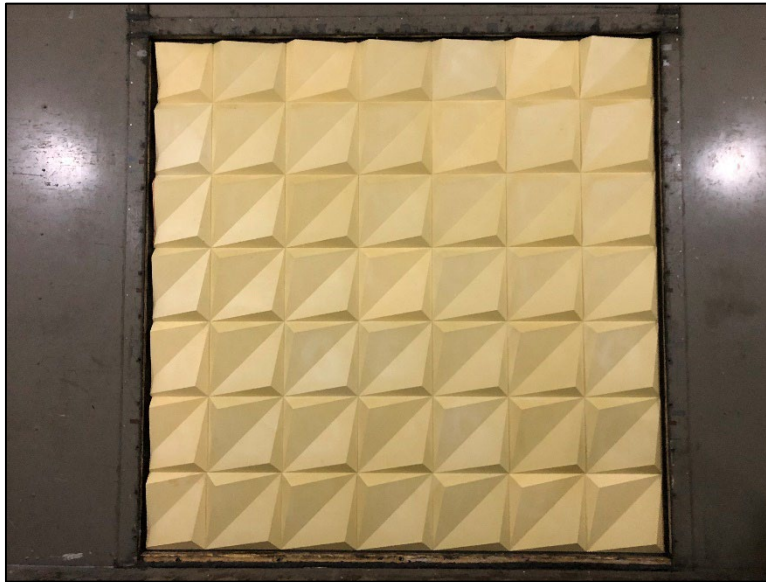
Photo No. 1
Receive Room View of Installed Specimen

SOURCE SIDE GYPSUM BOARD	One Layer, 5/8" Type X
STUDS	2X4 Wood
INSULATION	None
RECEIVE SIDE GYPSUM BOARD	One Layer, 5/8" Type X
3D WALL TILE	Vertical Illusion

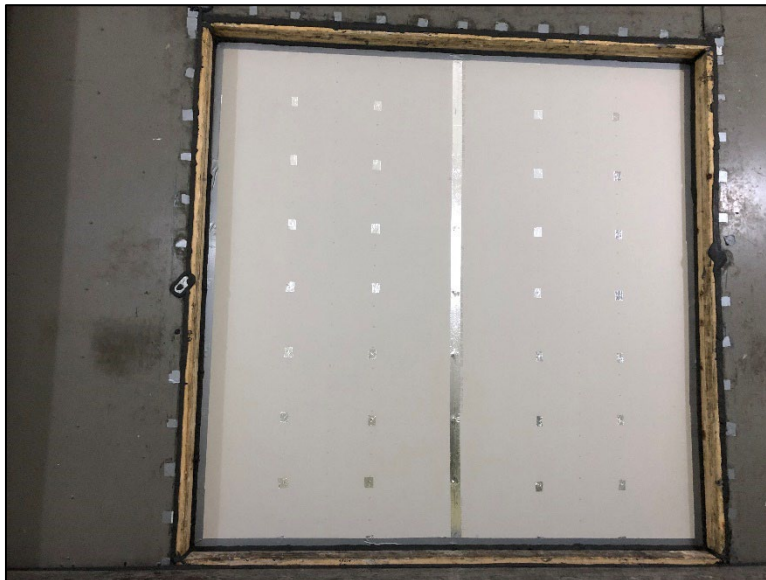
Photo No. 2
Source Room View of Installed Specimen
